Case 324 : Narrative

Case Vehicle (A): 2000 Dodge
Type: Stratus SE, 4-door sedan
Driver: 20-year-old female
CDC: 12-FDEW-5

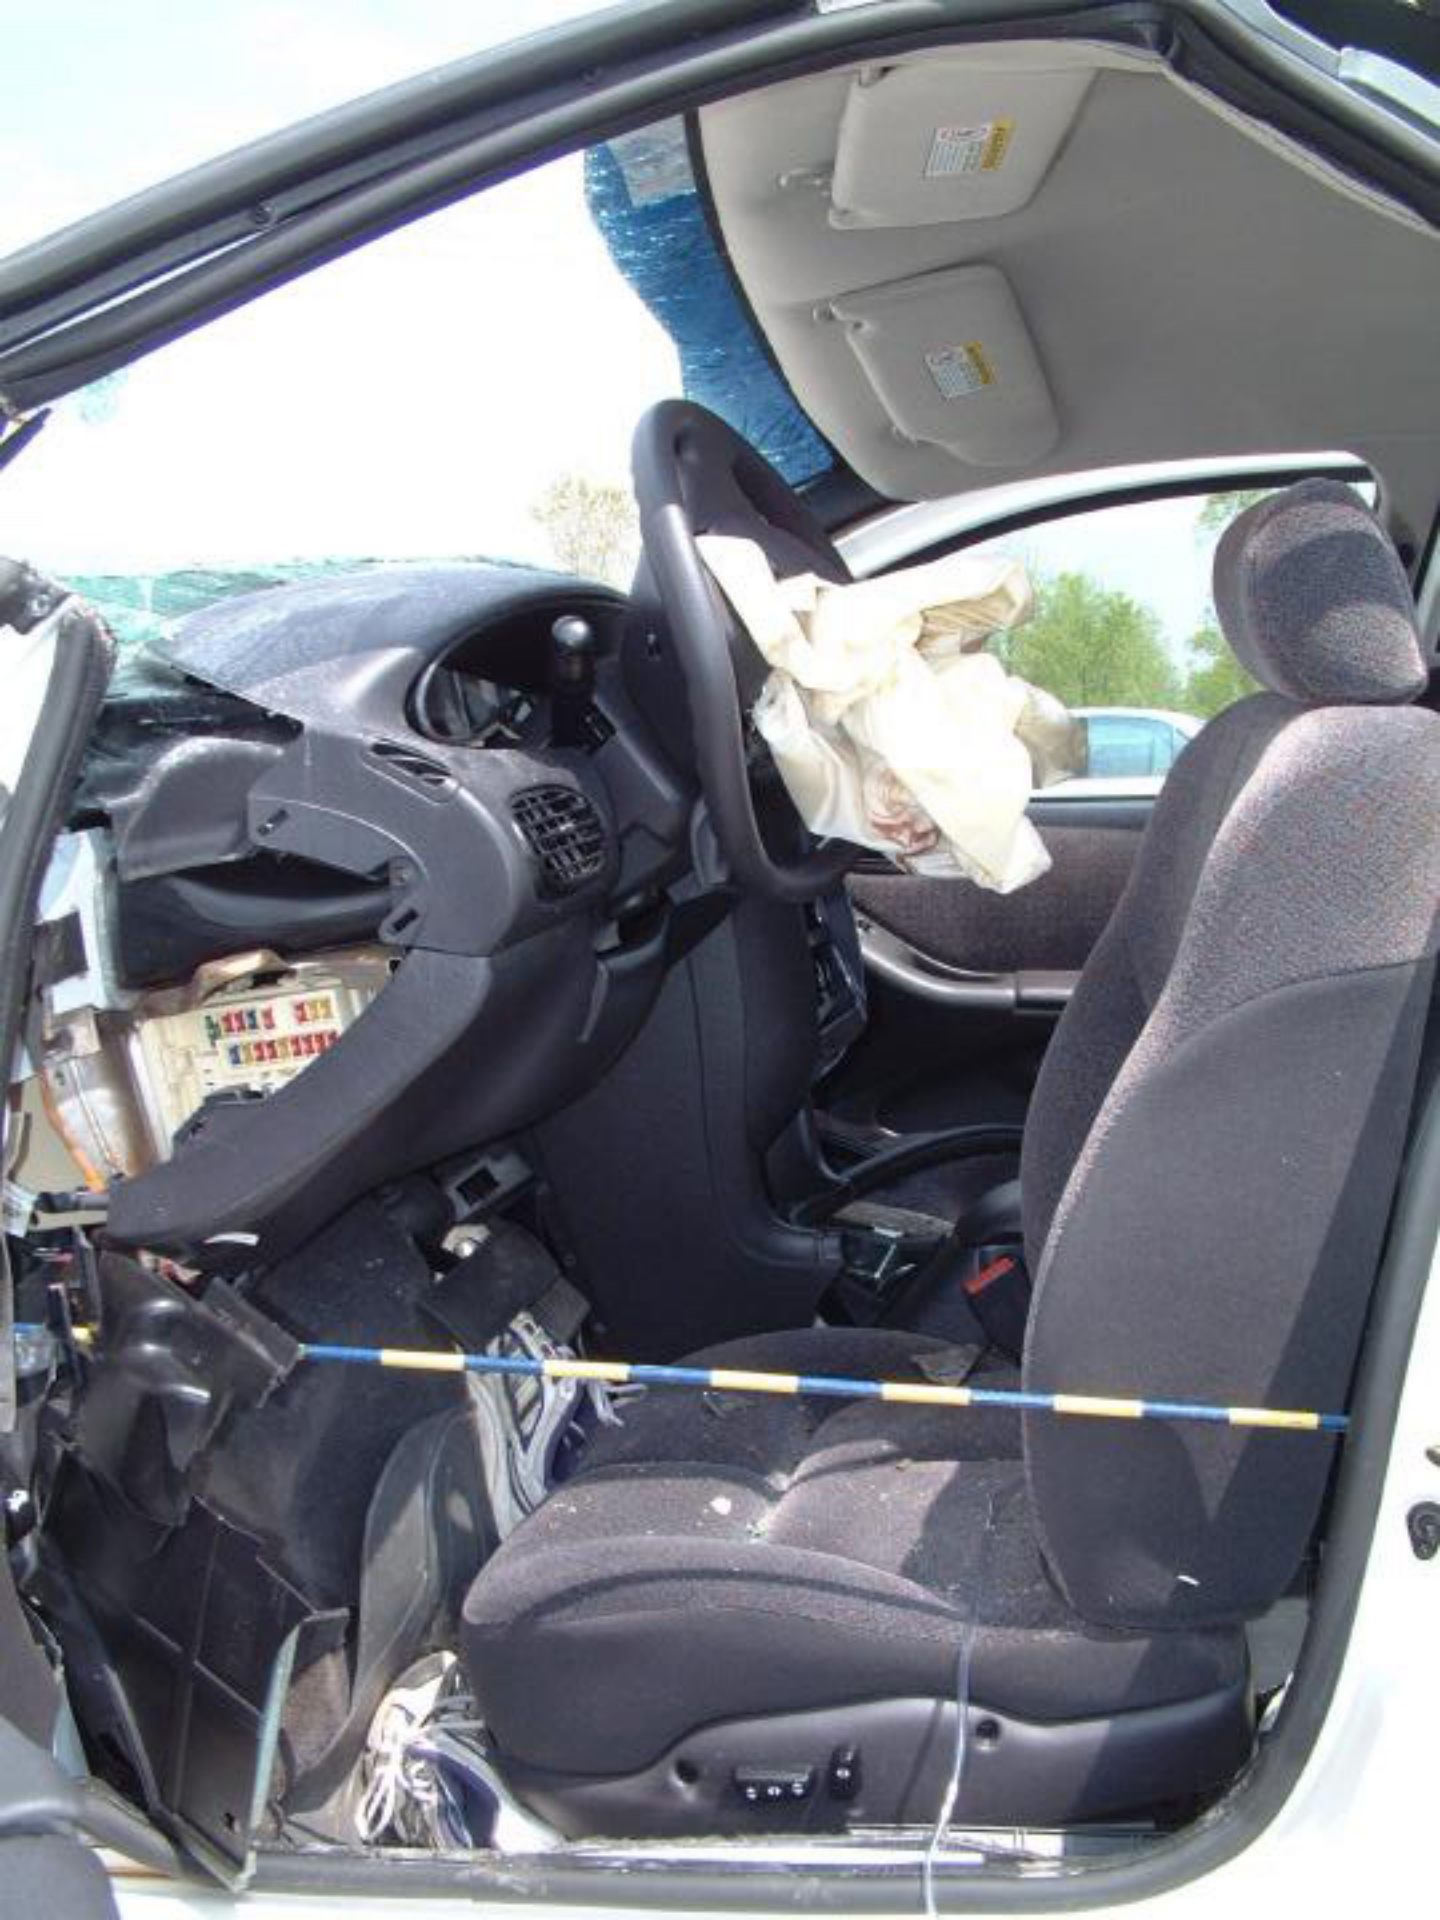
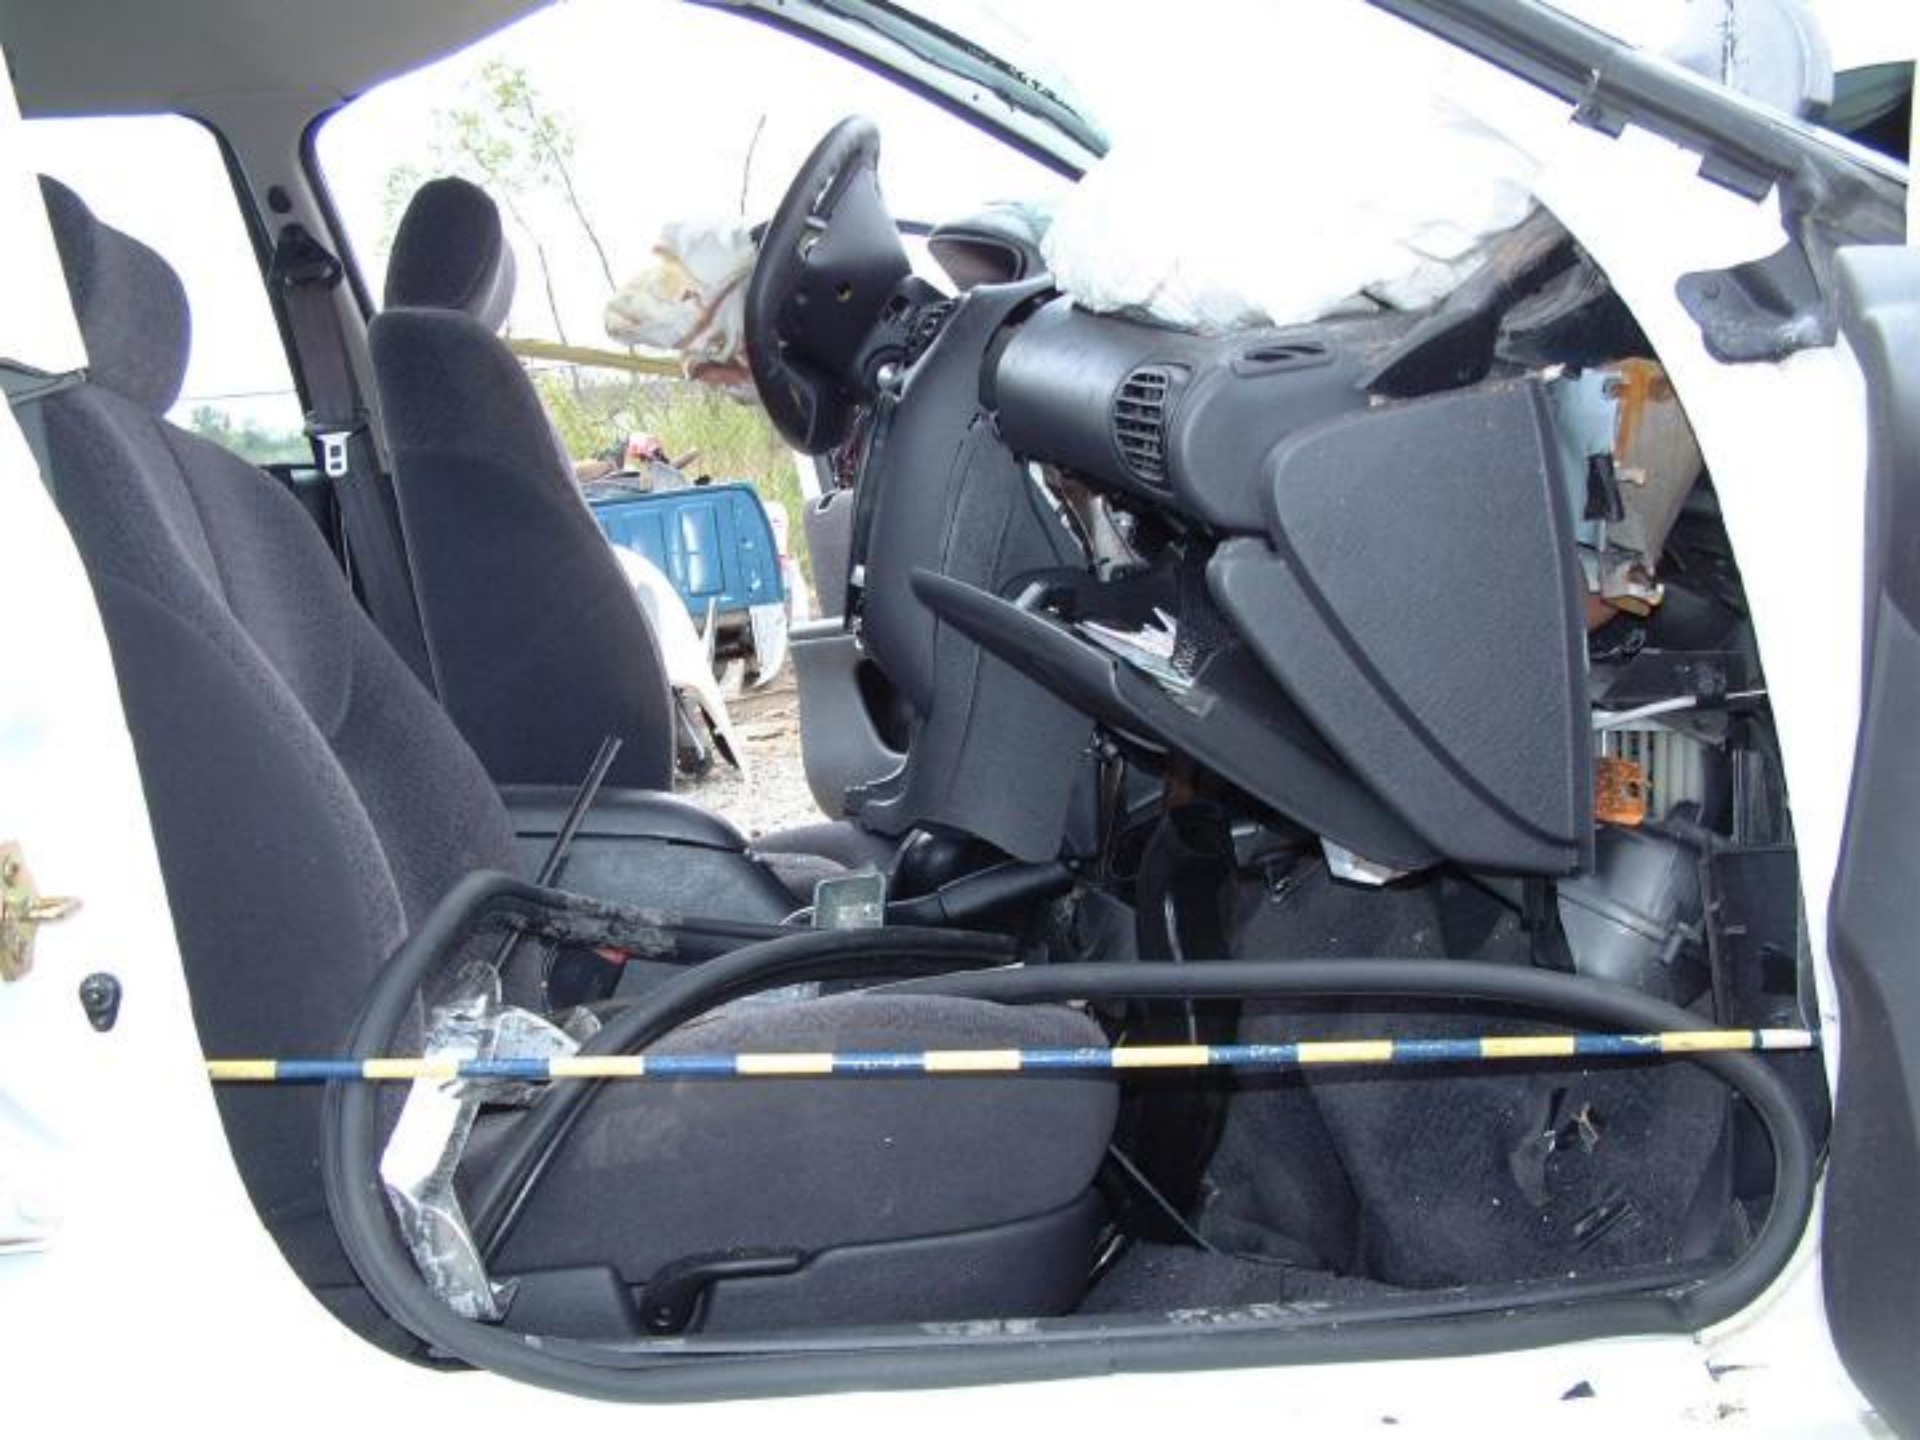
During the frontal impact, the female driver moved forward relative to the vehicle interior, into the belt restraints and the airbag. [82](#) [83](#) She sustained numerous head and face injuries, probably from contact with the steering-wheel rim through the airbag, due to the large airbag tear. These injuries include a right subarachnoid hemorrhage near the sylvian fissure, right frontal and temporal lobe intraparenchymal contusions, a left subcondylar mandibular fracture with anterior and medial displacement, a laceration to the lower lip, fractures to #12 and #13 teeth, and lacerations to the right aspect of the chin. She also sustained a laceration to the right posterior aspect of the scalp from an unknown source. She sustained a pulmonary contusion to the upper aspect of the right lobe of the lung, possibly from close-proximity chest loading by the airbag, from chest loading by the shoulder belt, or from chest contact with the steering wheel through the torn airbag. She sustained an abrasion and contusion to the lower-left aspect of the abdomen, probably from loading by the lap belt.
